J. ARONSTEIN
CONSULTING ENGINEER

HAZARDOUS FPE CIRCUIT BREAKERS **AND PANELS**

Information for Homeowners, Inspectors, and Electricians
(Updated November 10, 2017)

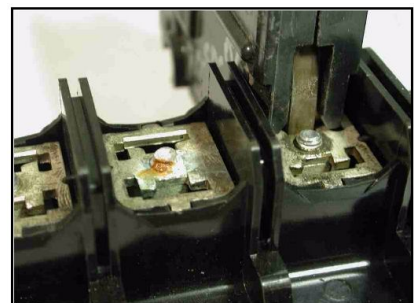
C. Stab socket on a post, attached with an 8-32 steel screw.

Of the three types illustrated above, the one shown in Figure 2-C is known to have a high probability of deteriorating and overheating of the stab socket structures when subjected to significant current flow. Each individual stab socket plate is connected to its bussbar via a post (spacer), and the assembly is held together by an 8-32 steel screw. FPE panels with this construction are prone to overheating failure. Eight of the panels of the present study that showed evidence of serious overheating were constructed this way. One example is shown in Figure 3.

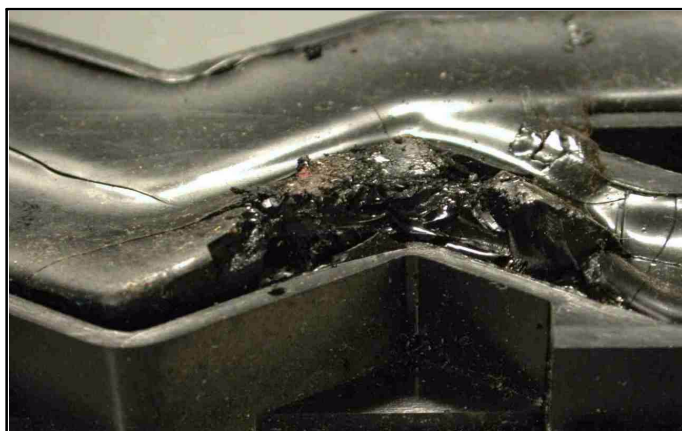
FIGURE 3 - OVERHEATING AT THE CONTACT BETWEEN THE BUSSBAR AND THE STAB SOCKET ASSEMBLY CAUSED THIS DAMAGE TO THE INSULATION.
(This view is of the backside of the panel. The damage cannot be seen unless the panel is taken out of the enclosure.)

A more serious failure of this type has been documented.¹ In that instance, the failure had been severe enough to ignite a smoldering fire on the plastic insulating material. The fundamental weakness in this design is the use of a single, relatively flimsy 8-32 screw to hold a structure together that can feed up to four half-width breakers with a total "ampacity" (rated circuit capacity) up to about 160 Amps. Figure 4 shows how the stab socket plate and post are attached to the bussbar.

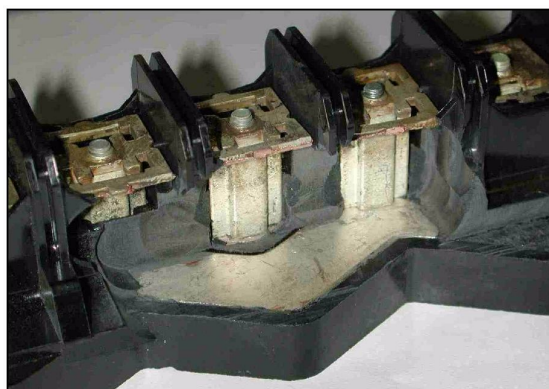
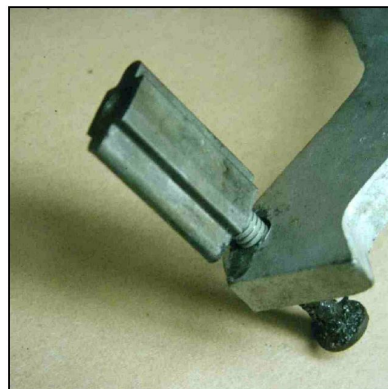
FIGURE 4 - CONDUCTING PATH FROM BUSSBAR TO STAB SOCKET

Various material combinations were utilized by FPE in these assemblies. Some bussbars are copper, others are aluminum. Some posts are copper, others are aluminum. The worst case (most likely to fail) is where both the bussbar and the post are made of aluminum, and the best case (least likely to fail) is where both are made of copper. Inspectors (or homeowners, or electricians) have no way of knowing which materials are utilized in any particular FPE panel with this type of construction.

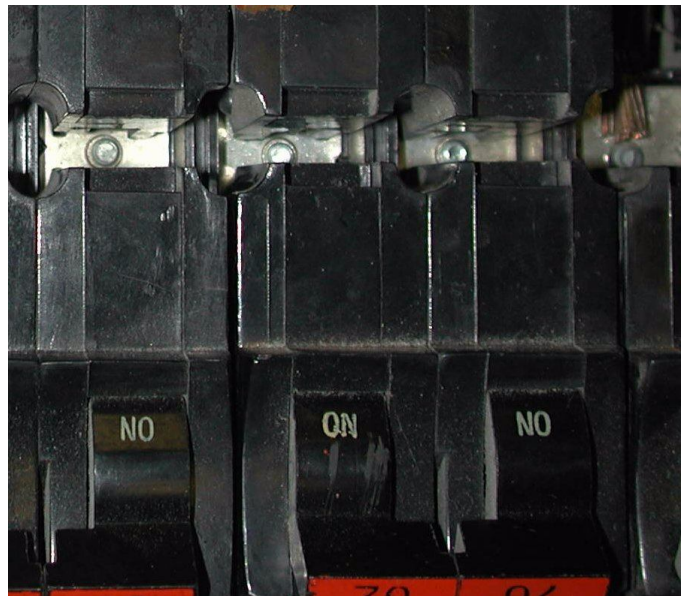
Inspectors can, however, determine if a particular FPE panel has this type of construction, and, to a limited extent, whether it has failing bussbar interconnections that have previously overheated. With the panel cover off, for this type of panel, the inspector can see the ends of the screws that attach the stab socket plates, as shown in Figure 5. (Note: If there are slotted screwheads visible, that is a different type of panel construction.) The stab socket plates and the visible ends of the screws should have a bright metallic look. Darkening, discoloration, or signs of corrosion most likely indicate past episodes of abnormal overheating.

FIGURE 5 - THE ENDS OF THE SCREWS HOLDING THE STAB SOCKET PLATES ARE VISIBLE BETWEEN THE TWO ROWS OF BREAKERS. THIS IDENTIFIES IT AS A PANEL OF THE TYPE SHOWN IN FIGURE 2-C

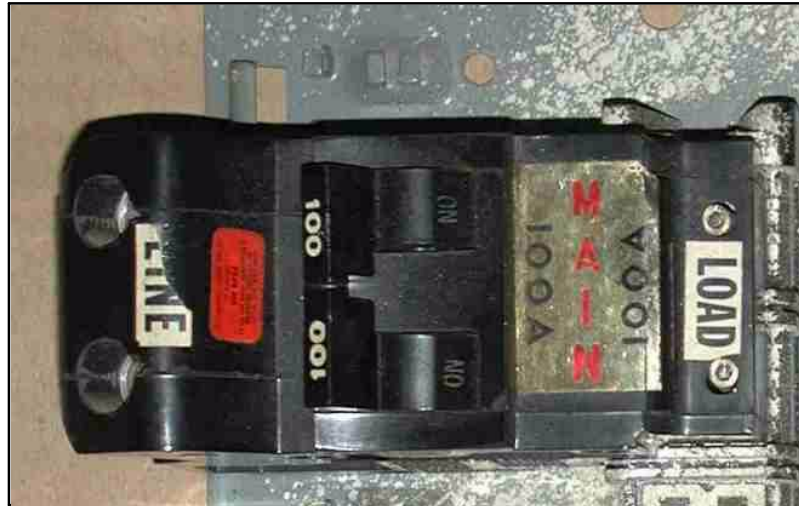
Some FPE Stab-Lok[®] panels have 100-amp main breakers that feed into the bussbars through the same plate and post system. In this design, the two main breaker output terminals do not have the stab type contact. Instead, each one is screwed down to a plate the same size as the stab socket plate, but which has a threaded hole in it instead of the stab openings. As with the plate and post assembly, the screws clamping the main breaker to the busbar assembly are size 8-32, which is absurdly small for a 100-amp main breaker connection, and this is another common point of overheating failure.

FIGURE 6 - FPE 100-AMP MAIN BREAKER CONNECTS TO THE BUSBARS THROUGH THE PLATE & POST CONFIGURATION, USING ONE SOCKET-HEAD 8-32 SCREW FOR EACH POLE TO ATTACH TO ITS CONTACT PLATE.

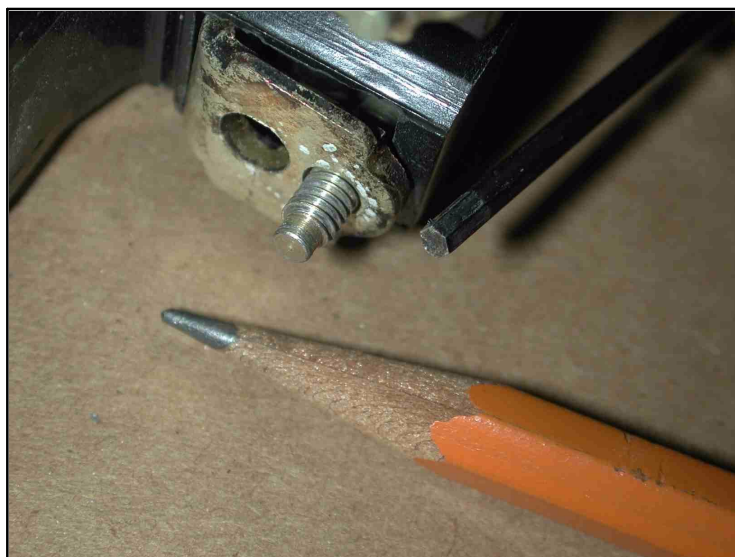
To put the diameter of the 8-32 screw in perspective, it is the same size as used on common receptacles for connecting #14 or #12 copper wire (for 15- and 20-amp circuits), with a diameter of only about 5/32". An FPE panel and main breaker of this type is shown in Figure 6. The main breaker's output terminal mounting screws and the tiny Allen-wrench that fits them are shown in Figure 7.

FIGURE 7 - ONE LOAD-SIDE CONTACT AND ITS 8-32 CLAMPING SCREW, ON THE FPE 100-AMP MAIN BREAKER OF FIG. 6. THE SCREW-HEAD TAKES A 3/32" ALLEN WRENCH, WHICH IS ONLY SLIGHTLY LARGER THAN THE LEAD OF THE PENCIL.

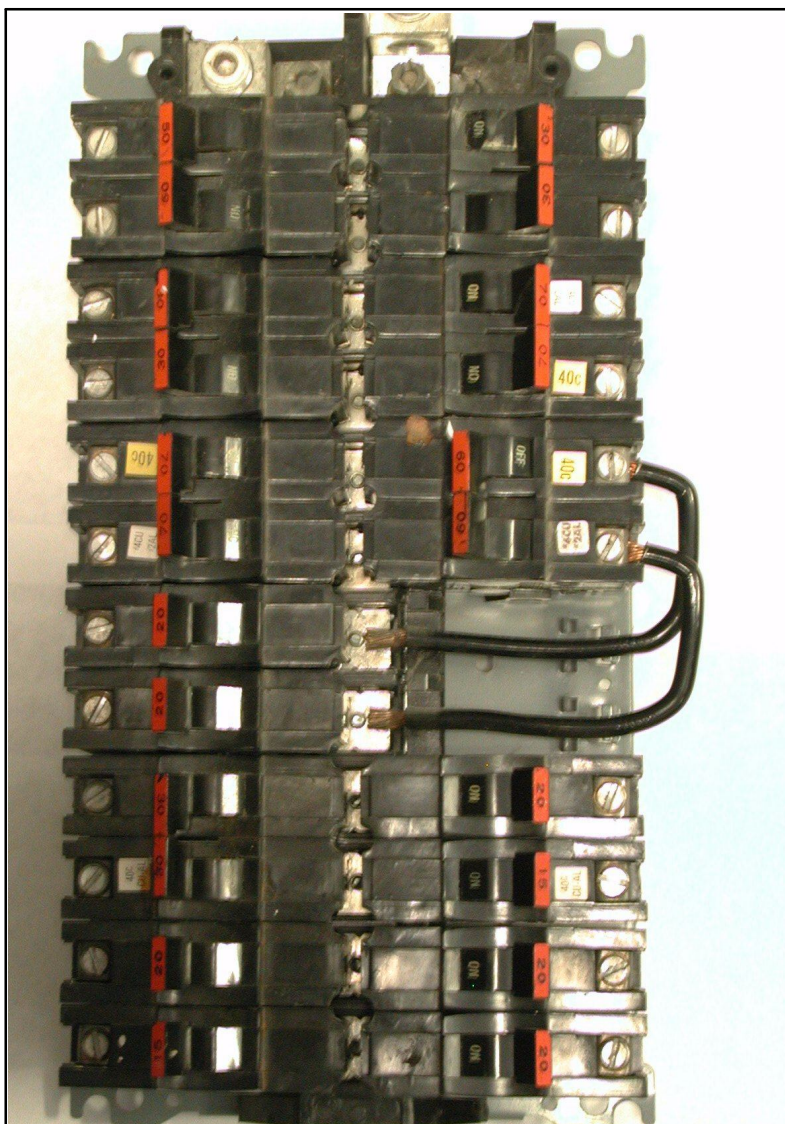
FIGURE 8 - FPE STAB-LOK® "RULE-OF-SIX" (SPLIT-BUS) PANEL WITH NO MAIN BREAKER. THE JUMPER CABLES ON THE RIGHT SIDE FEED THE LOWER SECTION.

On first glance, the FPE Stab-Lok® panel previously shown in Figure 8 looks normal. In fact, however, it clearly demonstrates several of the hazardous failure modes discussed in the previous sections. It is one of those collected for the recent testing. It is from a home built in 1974, whose new owners had determined in 1999 that it should be replaced. Their decision to replace it was in part prompted by information available on the internet regarding FPE breaker problems.⁷ According to the homeowner, who sent it to me for examination and testing, *"We recently had it replaced and found the breaker to the dryer fried in just the way described. Our electrician was astonished. Two others we had bids from dismissed our concerns with contempt."*⁸

Viewing the panel in Fig. 8 from the front, some signs of overheating (as previously discussed) are evident. These are subtle compared to the view looking down at the top right (dryer) breaker, as in Figure 9. The main service cable connector has been rotated out of the way for better visibility of the damage. The plastic insulator is burnt and cracked. The breaker's internal mechanism can be seen through the hole burned through its side.

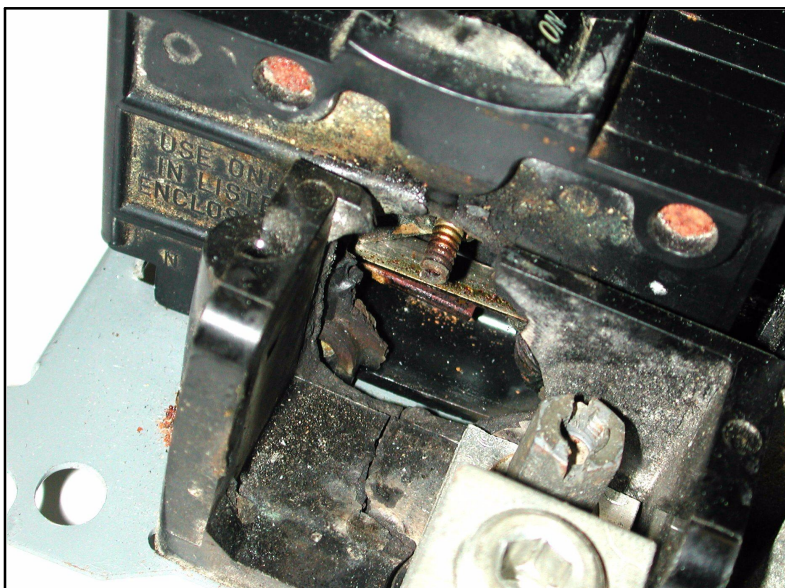
FIGURE 9 - VIEW DOWN TOWARD UPPER RIGHT OF PANEL SHOWN IN FIG. 8. THIS FPE STAB-LOK® TWO-POLE 30-AMP BREAKER FED THE CLOTHES DRYER.

The damage to the breaker, from some previous high current event, is exactly as had been demonstrated in the tests done for the CPSC.^{2,3,4} Those tests demonstrated that, when an FPE breaker jammed and the current exceeded about 300% of the breaker's rating, the side of the breaker disintegrated and/or ignited from the heat being generated within the breaker. This is due to resistive heating of the breaker's internal current-carrying components, mainly the bimetal element and the flexible copper braid that connects to it. This is not an arcing failure, although the damage to the insulating materials of the breaker and panel sets the stage for an arcing fault to occur.

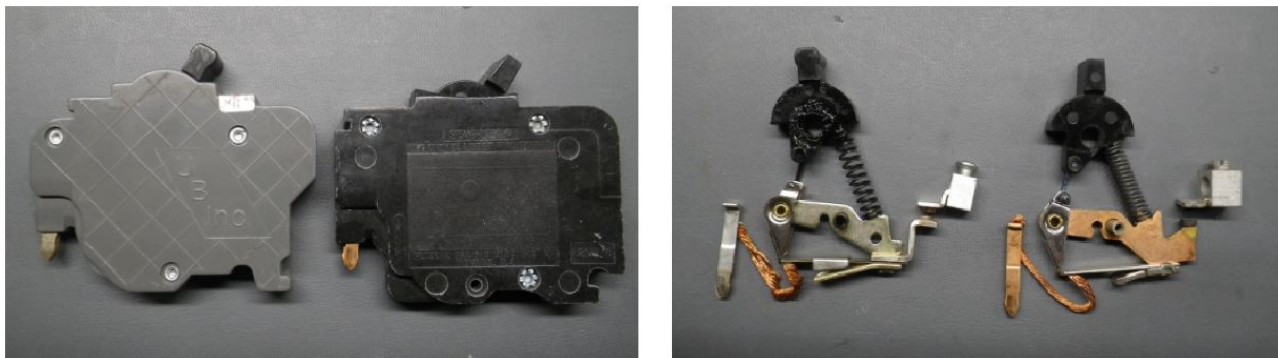
Replacing the FPE breakers with UBI-F breakers is definitely not recommended, as it is likely to result in an increased level of hazard. The UBI-F breakers, marketed by Connecticut Electric Products, are the only new breakers commonly marketed today in the U.S.A. as replacements for the FPE Stab-Lok® breakers. The UBI breaker housings look different, but internally the breakers are essentially the same design as the FPE breakers, as can be seen in Figure 10. The test results for UBI breakers are poor.

FIGURE 10 - UBI-F BREAKER AND FPE BREAKER, OUTSIDE AND INSIDE
(UBI on left, FPE on right in both photos)
