## The Importance of Kick-Out Flashing

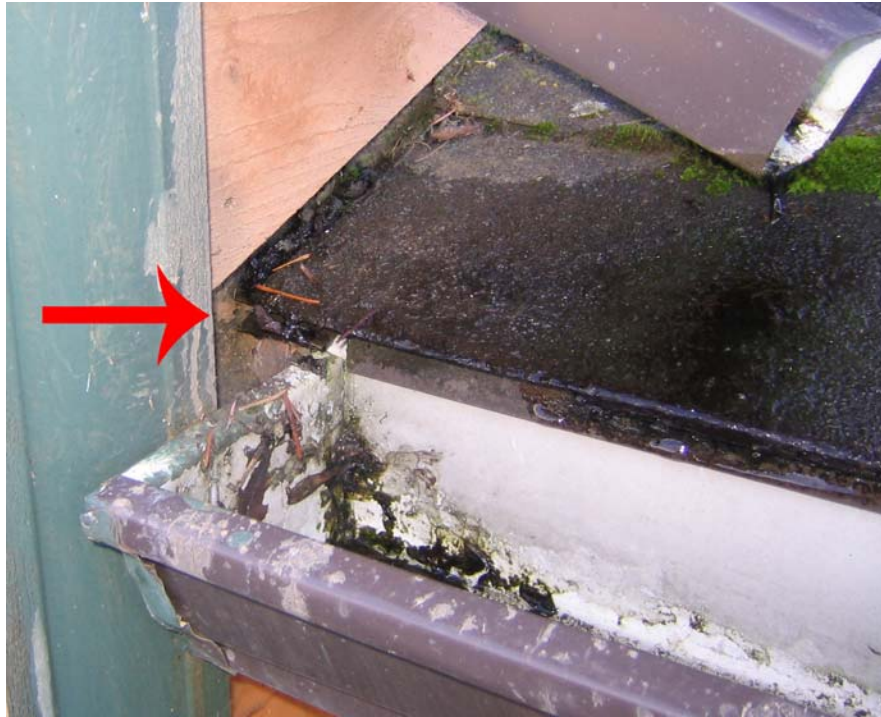
Here is a picture of inadequate kick-out flashing. Notice the gaps where water runs down the wall.

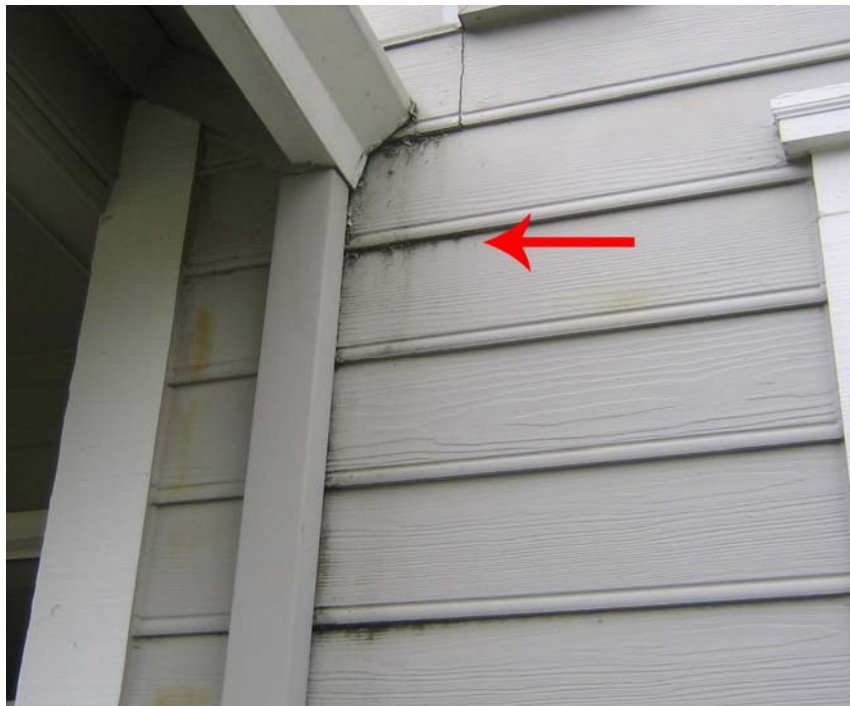
Here are some other telltale signs that kick-out flashing is either missing or improperly installed. Note the stains on the siding.

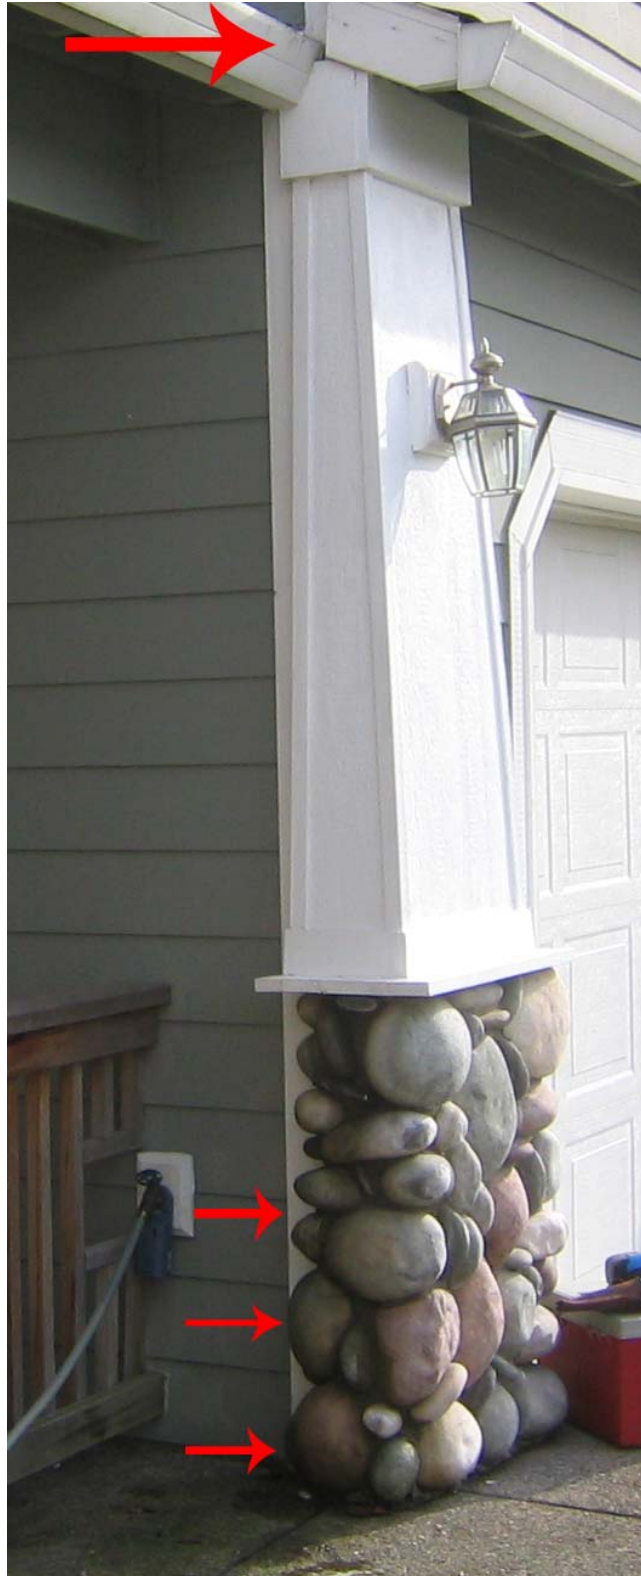
In this photo, you can see where water is coming out from behind the siding. Imagine the implications if this is not corrected.

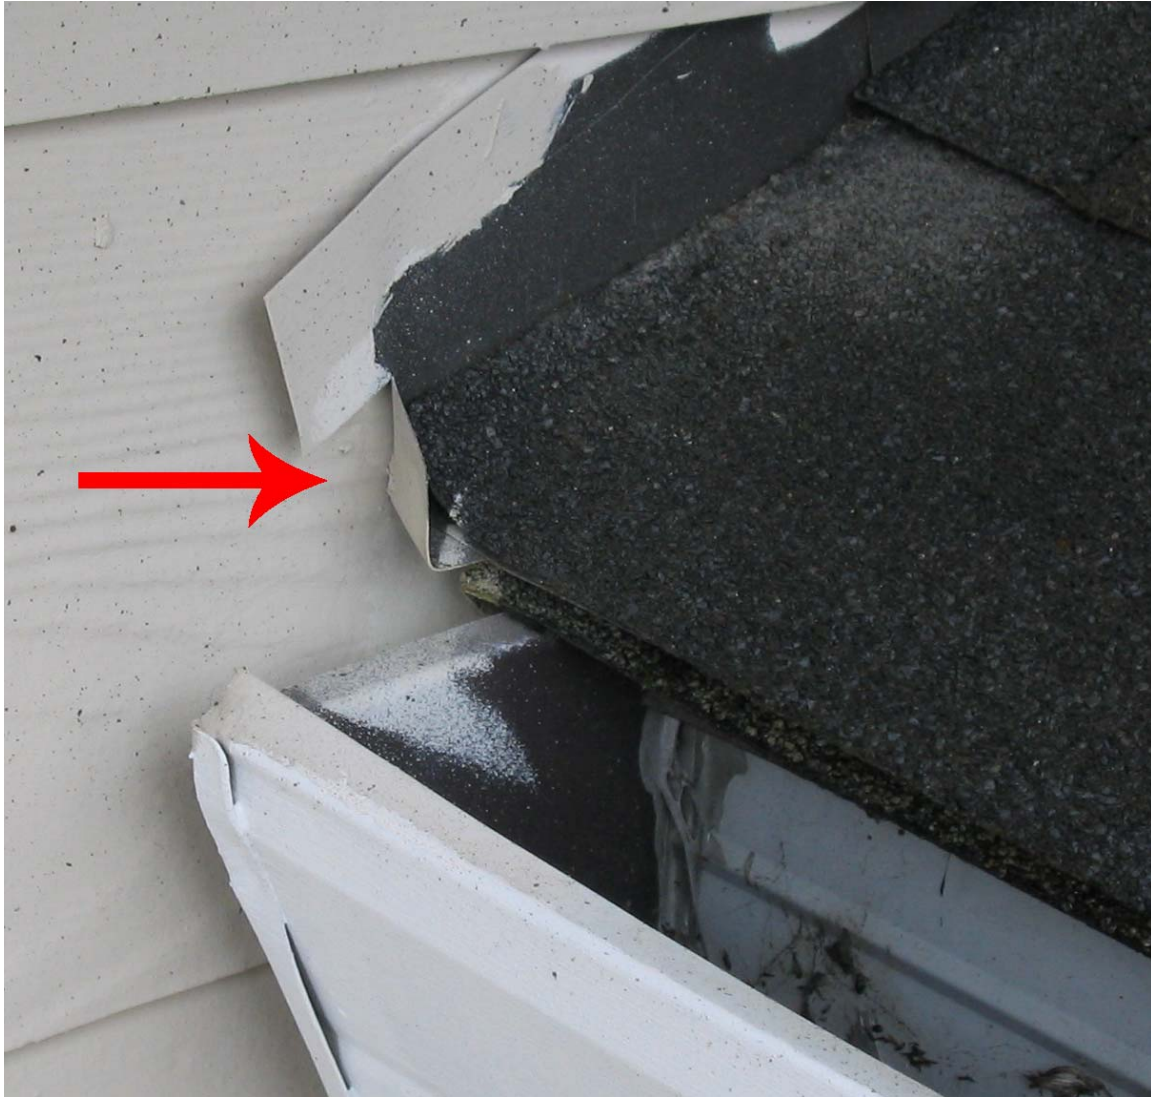
**This photo shows an attempt to use proper diverter flashing but it is not extended far enough past the roof edge to allow water to get into the gutter:**
