J. ARONSTEIN
CONSULTING ENGINEER

HAZARDOUS FPE CIRCUIT BREAKERS **AND PANELS**

Information for Homeowners, Inspectors, and Electricians
(Updated November 10, 2017)

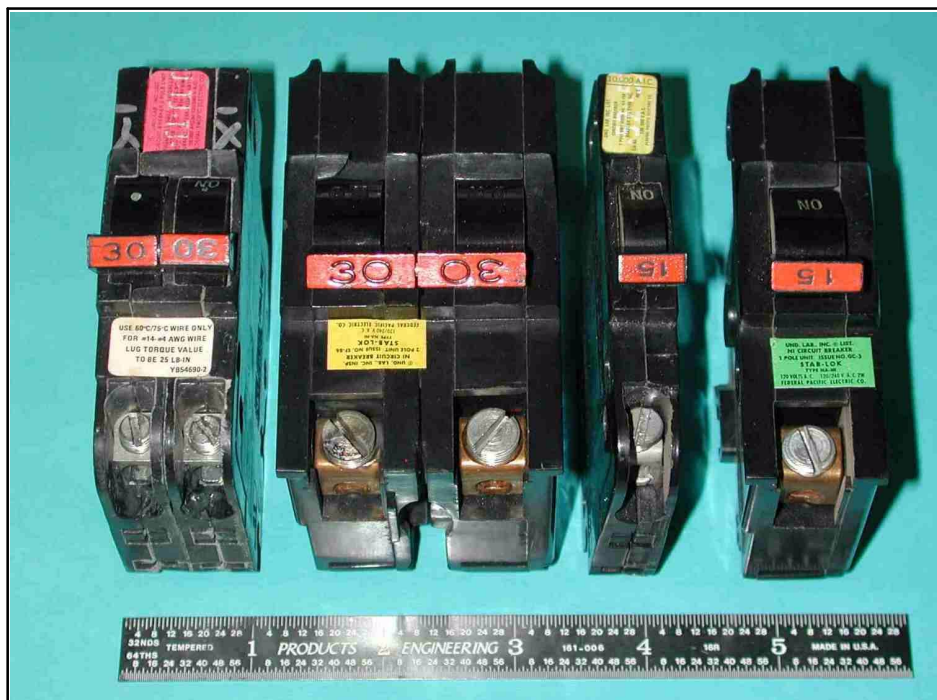
FIGURE 1 - REPRESENTATIVE SAMPLES OF HALF- AND FULL-WIDTH FPE STAB-LOK[®] CIRCUIT BREAKERS (left to right: 1/2-width double pole, full-width double pole, 1/2-width single-pole, full width single-pole)

Note that the color and style of the handle varied over the years, and that some FPE Stab-Lok[®] breakers (type NB) have screw connection to the bussbar instead of the "Stab-Lok" feature.

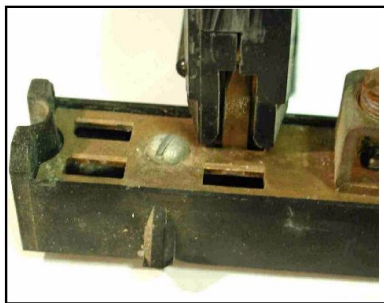
The "panel" is the unit within the enclosure, on which the breakers are mounted. The main electrical service feeders (electrically live, from the meter) are connected at the panel, and the panel has an internal conductor system that distributes the power to the individual circuit breakers. The internal conductor system consists essentially of "bussbars" (thick metal bars) that have sockets incorporated or attached, into which the breakers' "stab" contacts are inserted. There are several different bussbar and Stab-Lok[®] constructions used in FPE panels, three of which are shown in Figure 2.

A. Copper buss bar with punched openings.

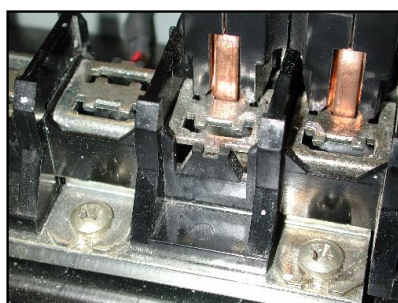
B. "Z" clip, clamped to . bussbar with 10-32 screw.

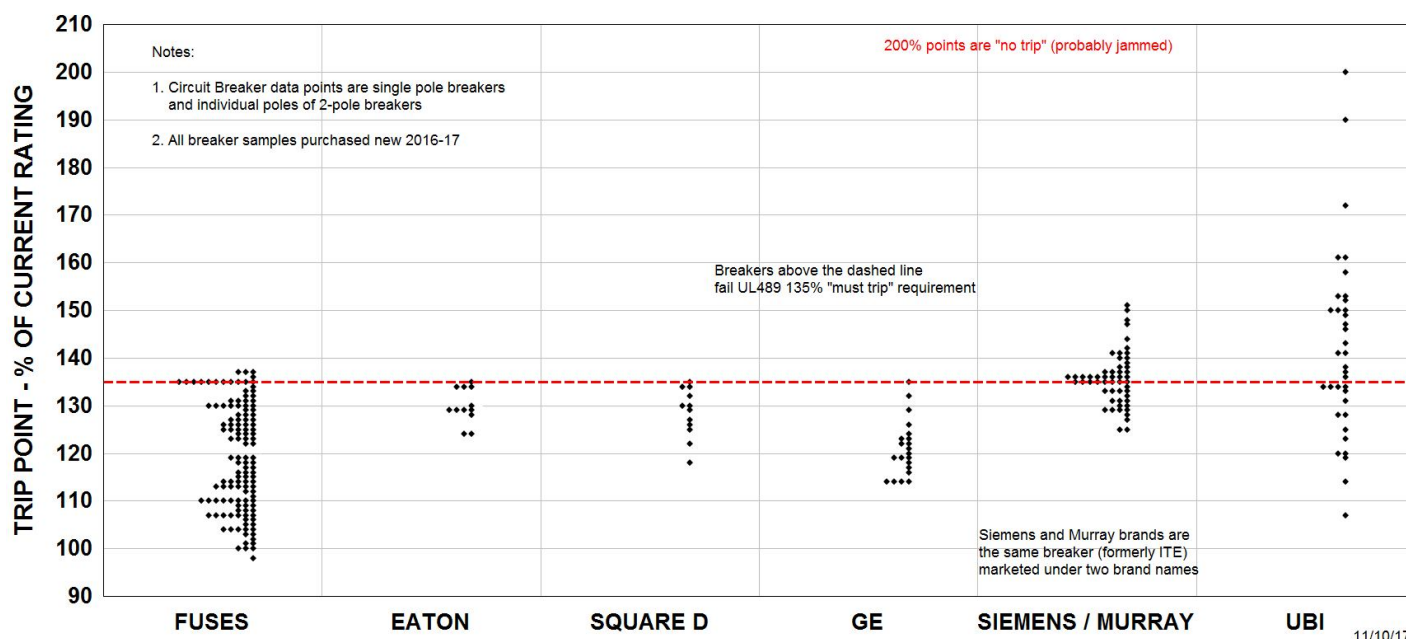
If it is necessary to increase the amperage capacity of the service, then a new enclosure and panel inside it must be installed. Eaton, Square D, and General Electric circuit breakers have performed well in tests of new breakers and breakers from homes. Recent test results for Siemens and Murray breakers, and their predecessor ITE show a high failure rate for the 135% trip requirement, and these brands are not recommended. Test results on several brands of circuit breakers, purchased new in 2016 and 2017, are shown in Figure 11.

FIGURE 11 - TEST RESULTS: FUSES AND NEW CIRCUIT BREAKERS

There are two options for replacement of the FPE Stab-Lok® panel. If it is not required to increase the service to higher amperage capacity, Eaton makes replacement panel inserts that install in the existing FPE enclosure.
